Port Townsend Waterfront Eelgrass Survey

September 5 & 8, 2014

Ian Fraser

September 12, 2014

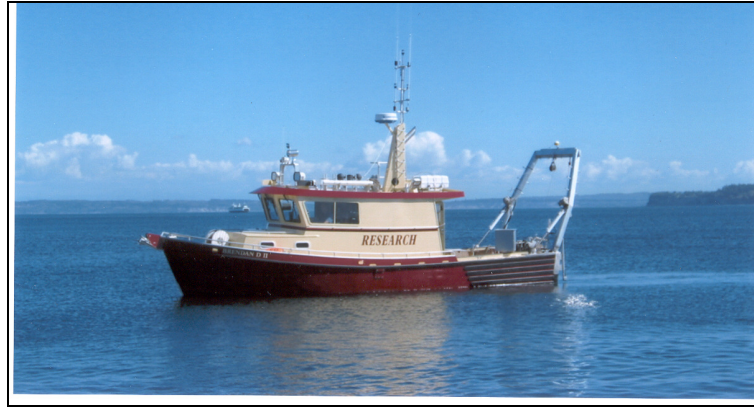
Figure 3. The R/V Brendan D II.

We conducted sampling aboard the 36-ft *R/V Brendan D II* (Fig. 3). We acquired position data using a sub-meter differential global positioning system (DGPS) with the antenna located at the tip of the A-frame used to deploy the camera towfish. Differential corrections were received from the United States Coast Guard public DGPS network using the WGS84 datum. A laptop computer running Hypack 2012 hydrographic survey software stored time, position and GPS quality data from the DGPS, depth data from one echosounder (Garmin), and user-supplied transect information onto its hard drive. Position data were stored in both latitude/longitude and State Plane coordinates (Washington South, US Survey Feet NAD83 HPGN). All data were updated at 1 s intervals. Table 3 lists all the equipment used during this survey.

For both echosounders, we mounted the portable transducers on poles attached to the starboard (Garmin) and port (BioSonics) corners of the transom. Since the DGPS antenna was mounted along the centerline of the vessel, each transducer was offset 1.5 m from the DGPS antenna. During analysis, we ignore this slight offset and assumed that depth readings from both depth sounders were taken at the location of the DGPS antenna.
