Voluntary Anchor-Free Eelgrass Protection Zone

A Non-Regulatory, Non-Harvest Marine Protected Area Project
in Port Townsend Bay, Washington

Phase II: Project Implementation

FINAL REPORT

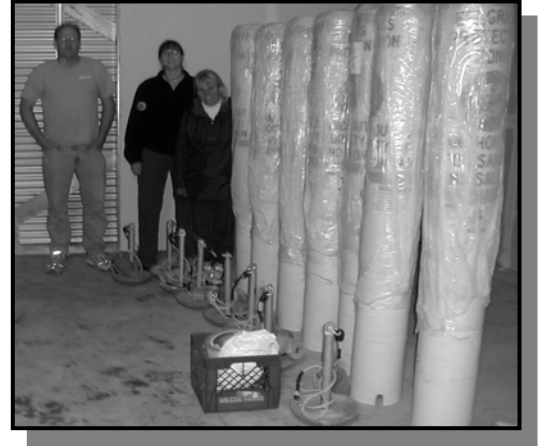
Buoy tackle construction work “party”.
Source: McConnell, 2004

In late-May of 2004 the project work group assembled the buoy tackle systems by splicing lines, adding mid-line floats and securing shackle pins with wire keepers. Line scope on each buoy was left long at 60’ to allow adjustment upon installation based on depth at location for each buoy. Regulatory permits required an additional 2’ of scope beyond the highest estimated tide for a total of 14’ above the water depth at mean lower low water (MLLW). Therefore, if the lateral and offshore placement located the buoy anchor in 20’ of water (MLLW) the scope would be 34’.

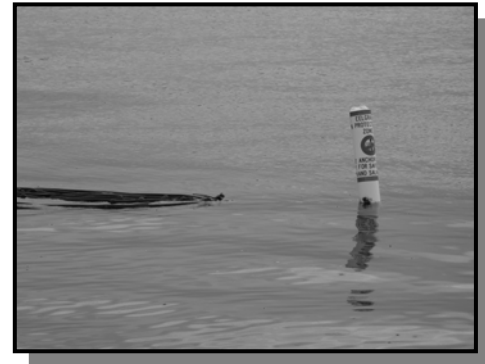
Kelp wrack caught on marker buoy.
Source: LaRoche, 2004

The effect of the strong tidal currents is believed to be the cause of the equipment failure, especially in light of repeated observations of kelp wrack (primarily bull kelp, *Nereocystis sp.*) entangled on the buoys. This additional surface area would only increase the buoy's drag and thereby the break-out

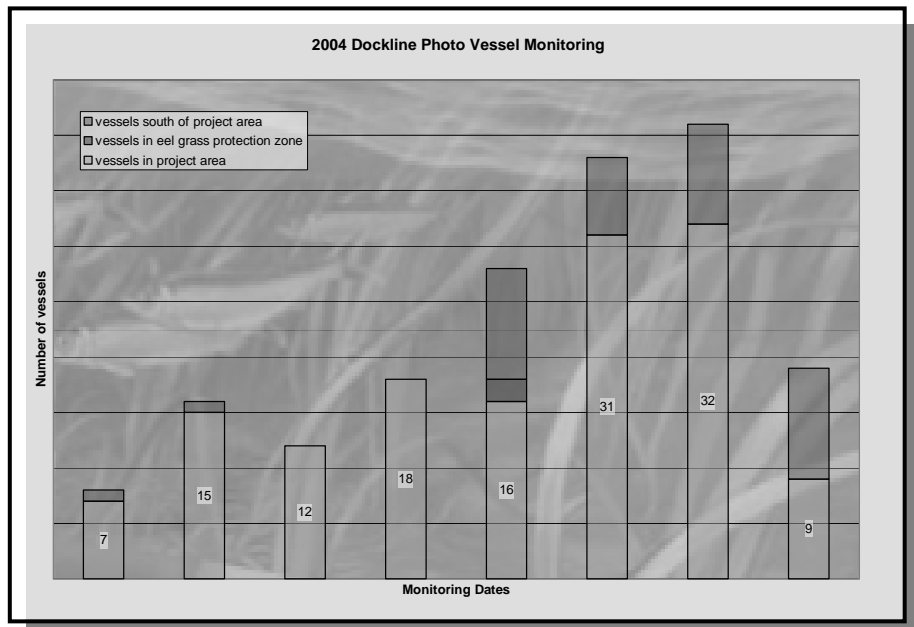
Above: 1999 eelgrass map by Marine Resources Consultants. **Below:** Chart of boating activities in and adjacent to the Voluntary Eelgrass Protection Zone. **Source:** Norris, 1999 and LaRoche, 2004 respectively

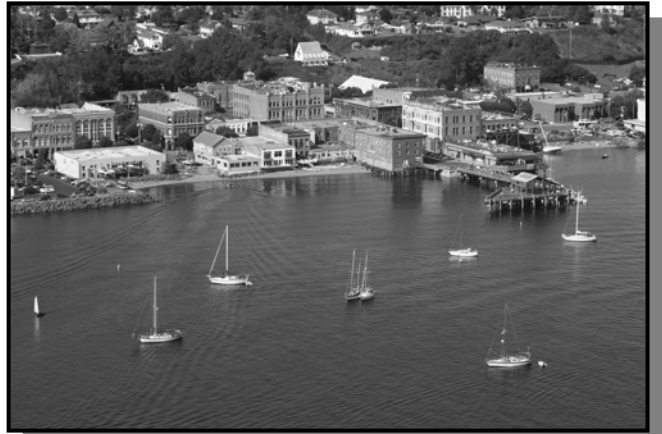
Even during Wooden Boat Festival weekend, 98.6% of boaters anchored outside the VEPZ. Source: Leader, 2004

Dockline photos were taken on 9 days during Phase II of the project and showed an average of only 1.4% of boats anchoring inside the VEPZ. (Appendix B) In addition,
