Port Townsend Waterfront Eelgrass Survey

July 27-30, 2022

Monica Montgomery
Jefferson County Marine Resources Committee
August 29th, 2022

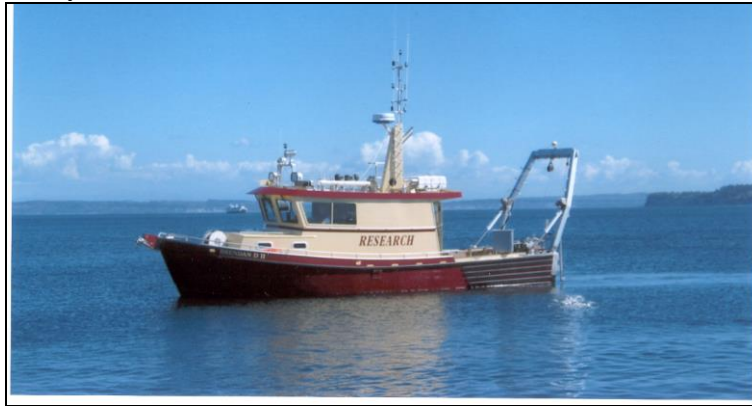
Figure 2. The *R/V Brendan D II*.

We conducted sampling aboard the 36-ft *R/V Brendan D II* (Fig. 3). We acquired position data using a sub-decimeter ATLAS corrected differential global positioning system (DGPS) with the antenna located at the tip of the A-frame used to deploy the camera towfish. Corrections were received from a Hemisphere ATLAS satellite correction network using the WGS84 datum. A laptop computer running Hypack 2021 hydrographic survey software stored time, position and GPS quality data from the DGPS, depth data from one echosounder (Garmin), and user-supplied transect information onto its hard drive. Position data were stored in both latitude/longitude and State Plane coordinates (Washington South, US Survey Feet NAD83 HPGN). All data were updated at 1 s intervals. Table 3 lists all the equipment used during this survey.
